Progress Review

Thermomechanical fatigue of Boeing 60-NiTi

10/10/2007

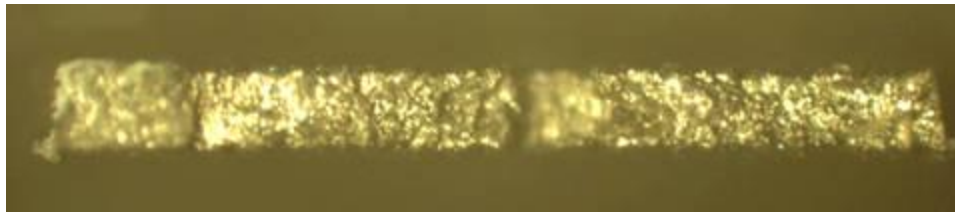
SP#3 HT1 – thickness = 5 mils

- Influence of thickness can be seen as cracks are generated in the transverse direction of SP#3 HT1 where PS#7 HT1 displays more of a bulk behavior
- Different failure behavior from thickness 5 mils to 15 mils

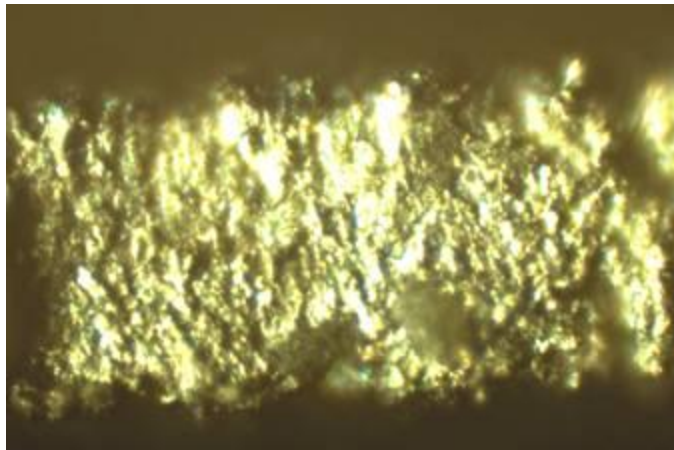
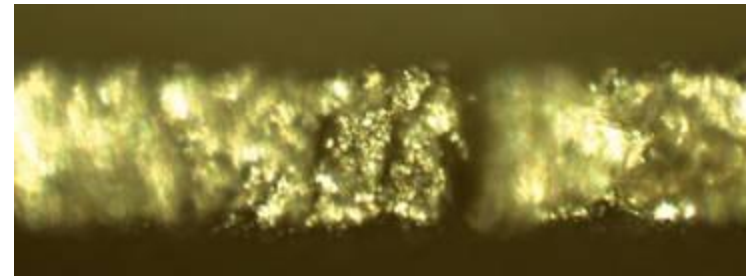
SP#3 HT1 – thickness = 5 mils

- Transverse cracks and transverse tear up – strong dependency on the width to height ratio
- Propagation of fatigue lines in a transverse pattern

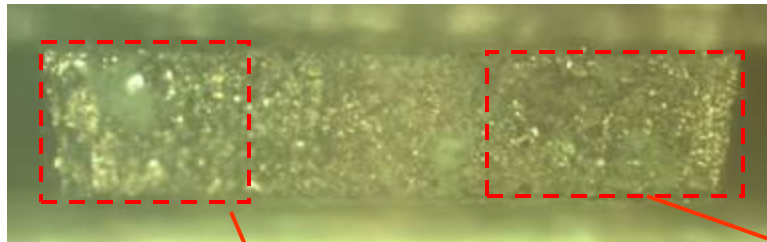
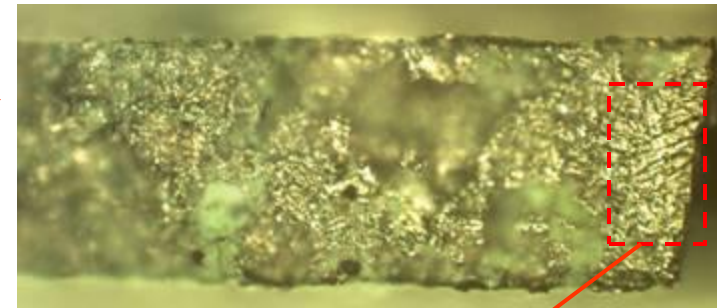
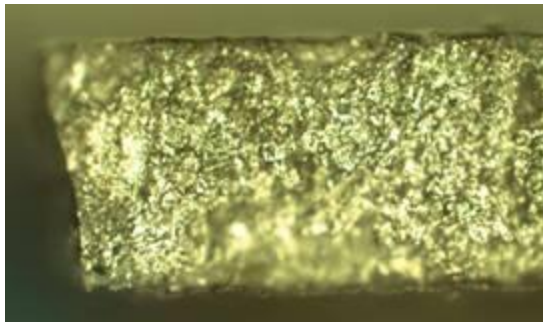
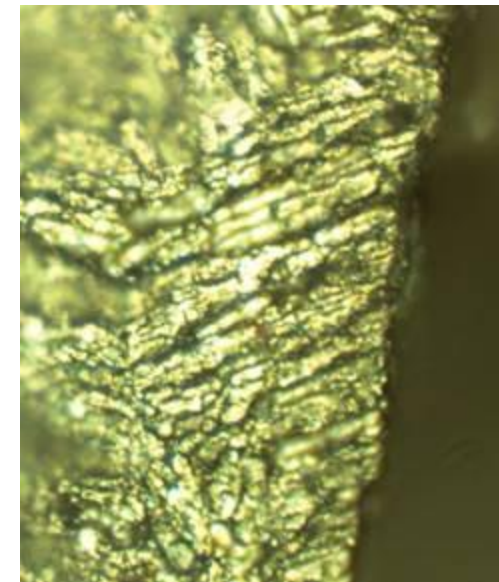
SP#6 HT2 – thickness = 10 mils

- Thicker specimens display bulk behavior with multi-axial fatigue damage and propagation
- **Notice the non-existence of contrasted surface layer: heat treatment performed in vacuum**

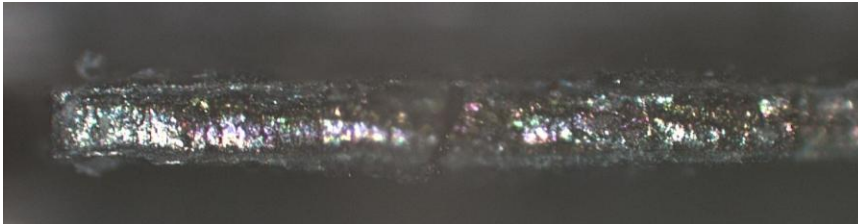
SP#6 HT1 – thickness = 5 mils

- EDM specimens failing too early under 100MPa and 150MPa applied stress led to analysis of oxide layer due to heat treatment performed in air vs. in vacuum

Nf (HT in air, 100 -150 MPa) < 2000 cycles

Nf (HT in vacuum, 100 – 150 MPa) \approx 50000 cycles

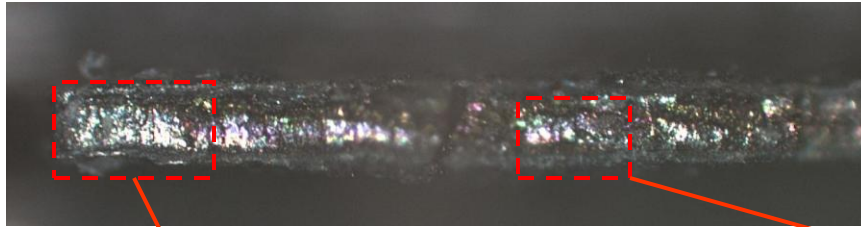
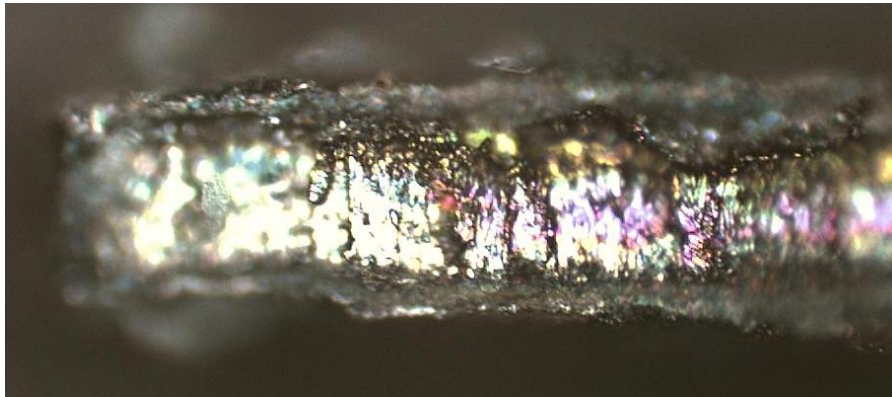
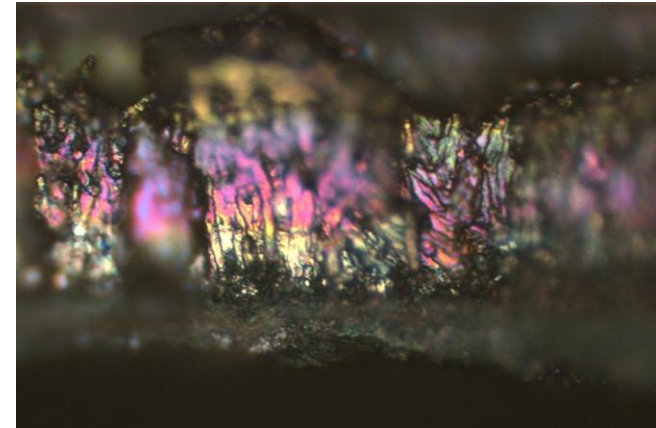
SP#6 HT1 – thickness = 5 mils

- **Similar transverse fatigue lines with crack propagation along the same direction**
- **Significant contrasted surface layer on the specimens: initial oxide layer formed upon heat treatment. Interface is clear and cracks can be identified**

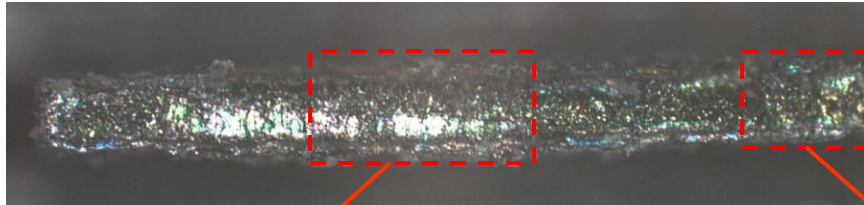
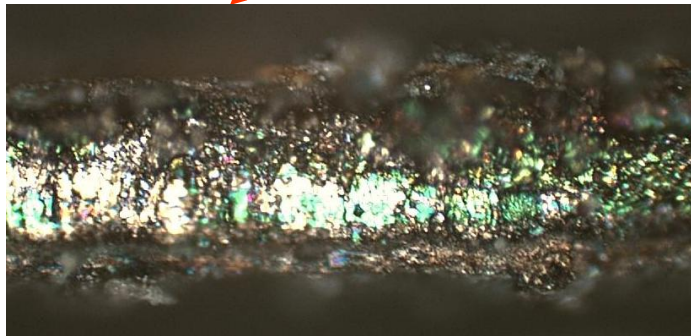
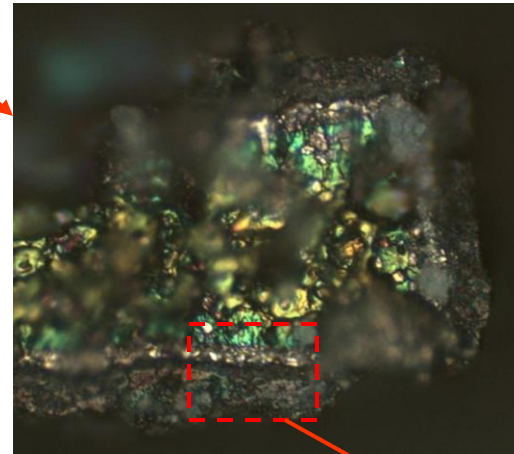
SP#8 HT2 – thickness = 5 mils

- Specimens with minimum thickness (5 mils), failed very early due to a significant oxide layer contributing to crack initiation and to embrittlement

- Selection of heat treatment for better control over fatigue experiments and to enhance time to achieve fatigue testing: **Heat Treatment 2**
- Stress range to perform fatigue testing needs to be adjusted to **100 – 150 – 250 MPa**
- Selection of ideal thickness for best material response is to be **15 mils** (20 mils if stress range reduced to 100 – 150 – 200 MPa)
- Modification of actual test matrix to account for suggested modifications
